Study Committee B3
PS2: Existing Substations, new challenges

Study and solution of Series Compensation Faults in Trunk Electrical System of Chile

J. Vargas, R. Suarez
TRANSELEC S. A.
Chile
jvargas@transelec.cl

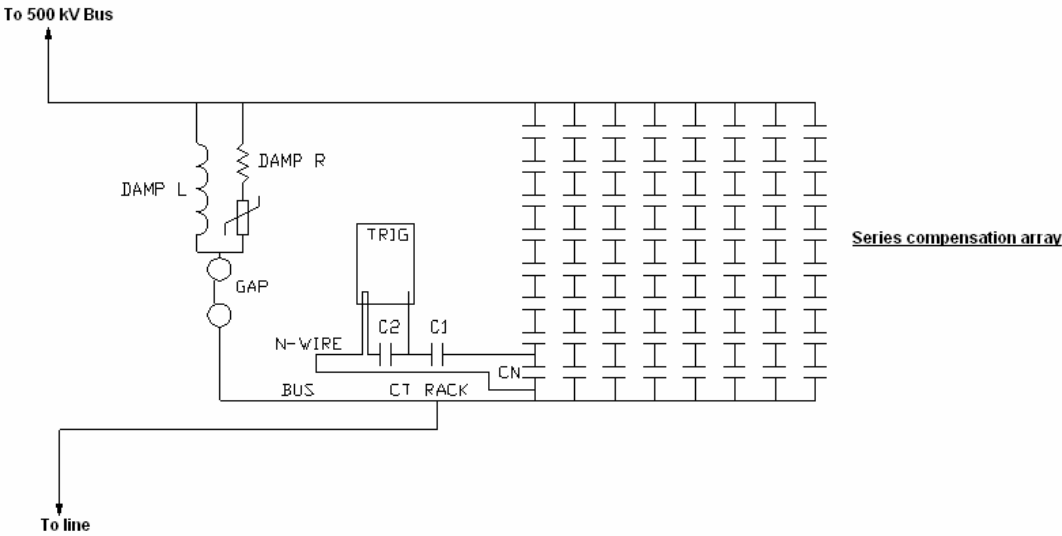
Figure 2. Layout of Series compensation equipment

The problem was that when occurred fault in the 500 kV line, sometimes the equipment was damaged and other times was not. In cases when the equipment was damaged different part and even different level of damage occurred, being the most severe which the circuit damping circuit was entire burned. The layout of the series compensation is showed in figure 2.

As it was said, there was a random behavior of the system with and without fault in the series compensation even in cases where apparently similar fault occurred.

According with the developing of the studies and activities, the problem was found and some changes in the design were done. All of these actions were done with the participation of the factory people which gives information about statistics of fault and different design between TRANSELEC's series compensation and other ones installed in other places.
